Gulf Coast Cogen Facility

PROJECT SUMMARY REPORT

**HIGH VELOCITY OIL FLUSH SERVICES
ABB STAL VAX STEAM TURBINE**

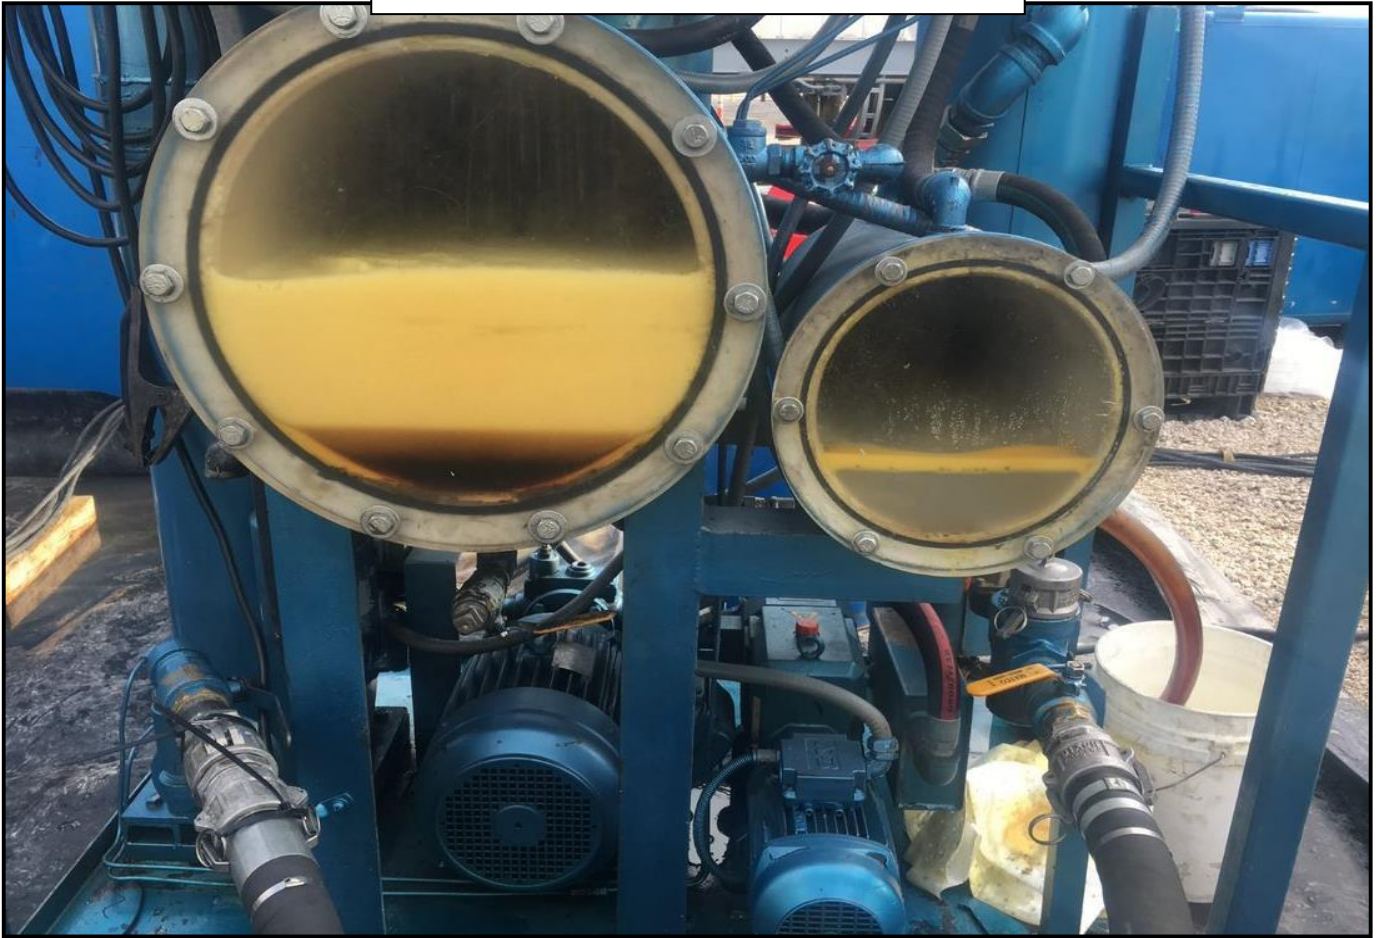
Vacuum Dehydrator Water Removal -
VDOPS

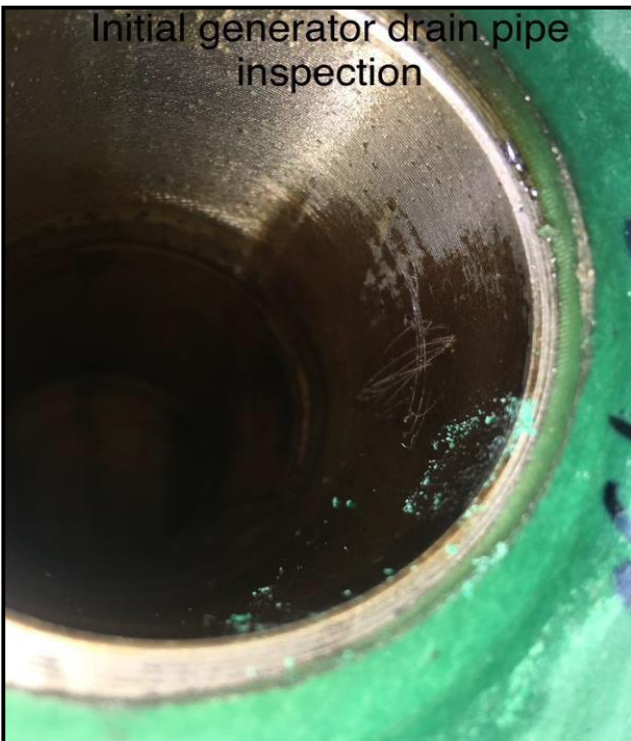
Initial generator drain pipe
inspection

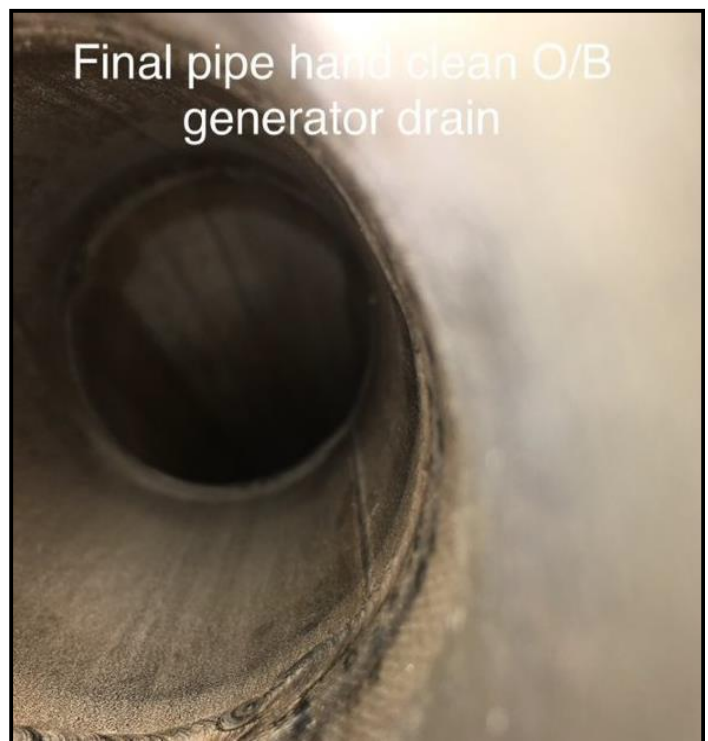
Final pipe hand clean O/B
generator drain

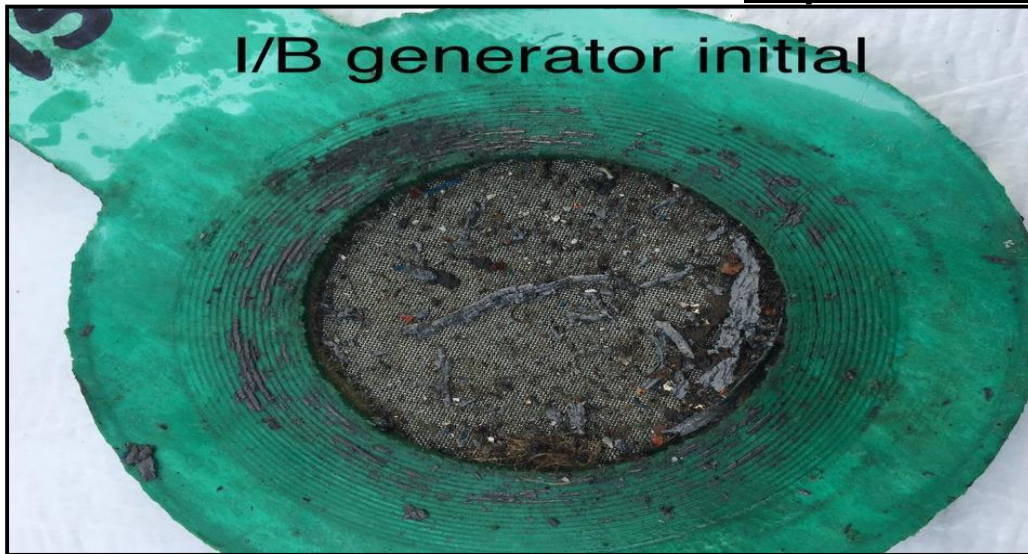
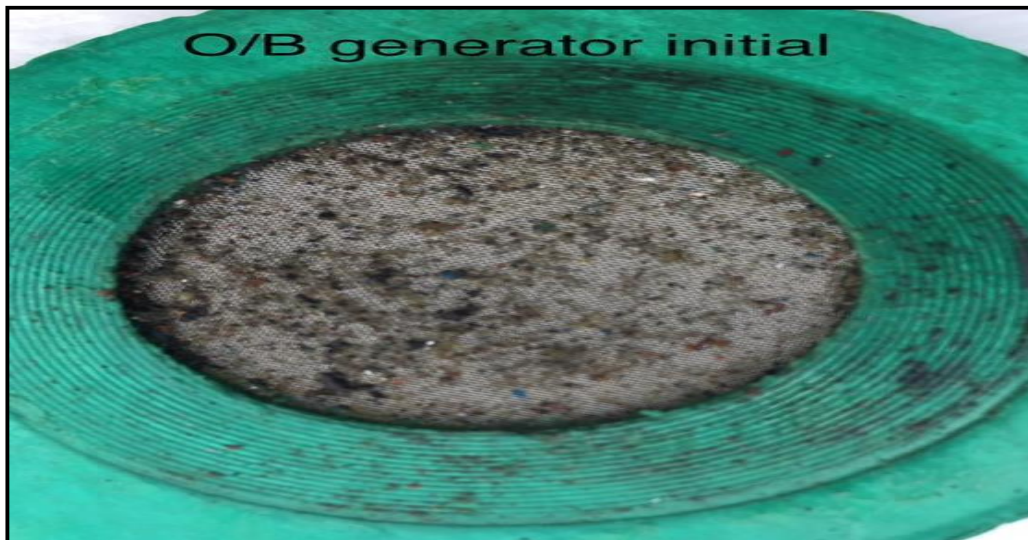
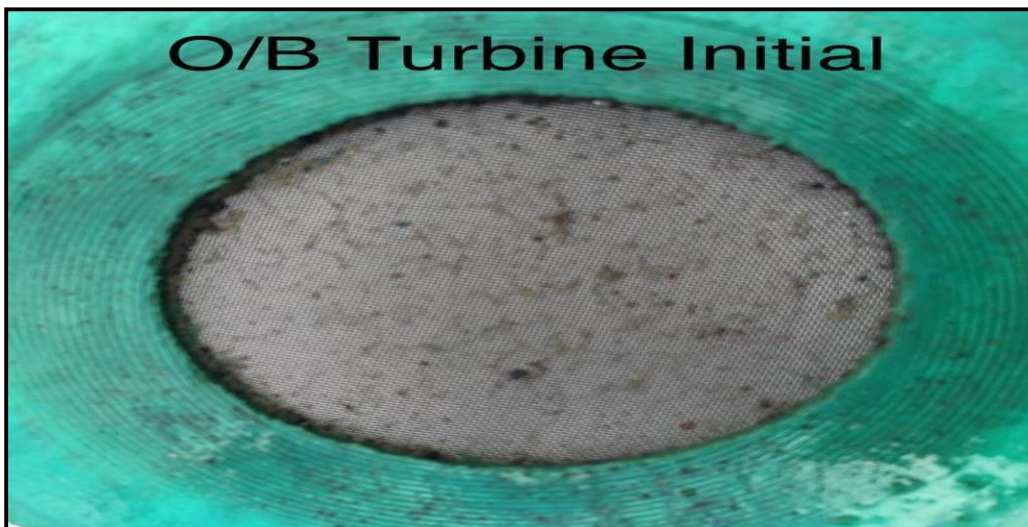
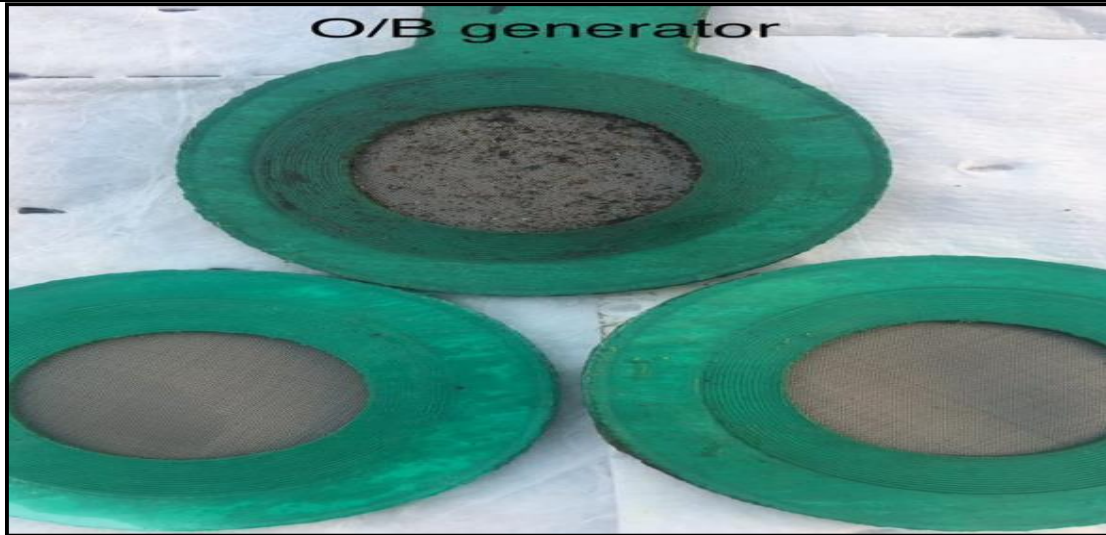
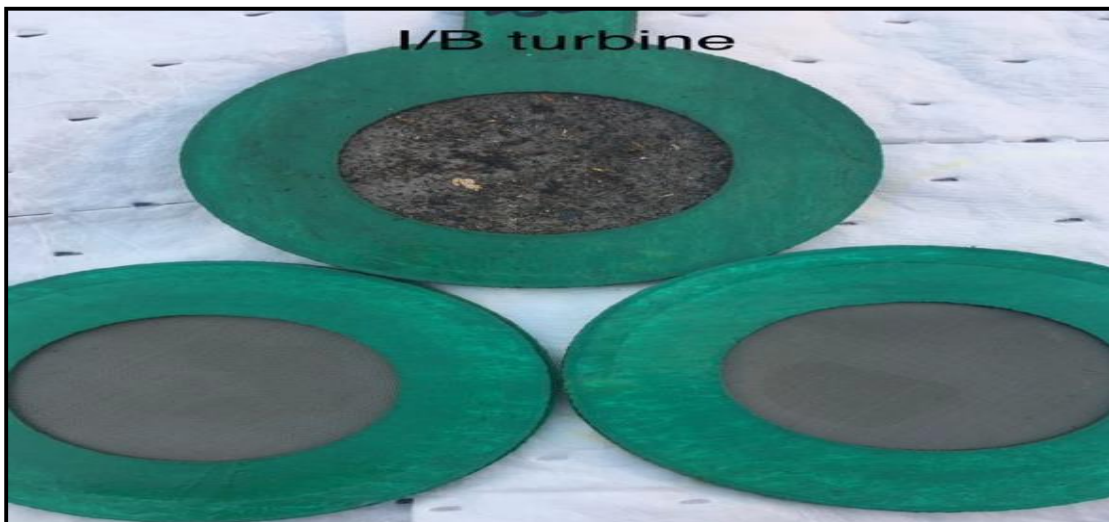
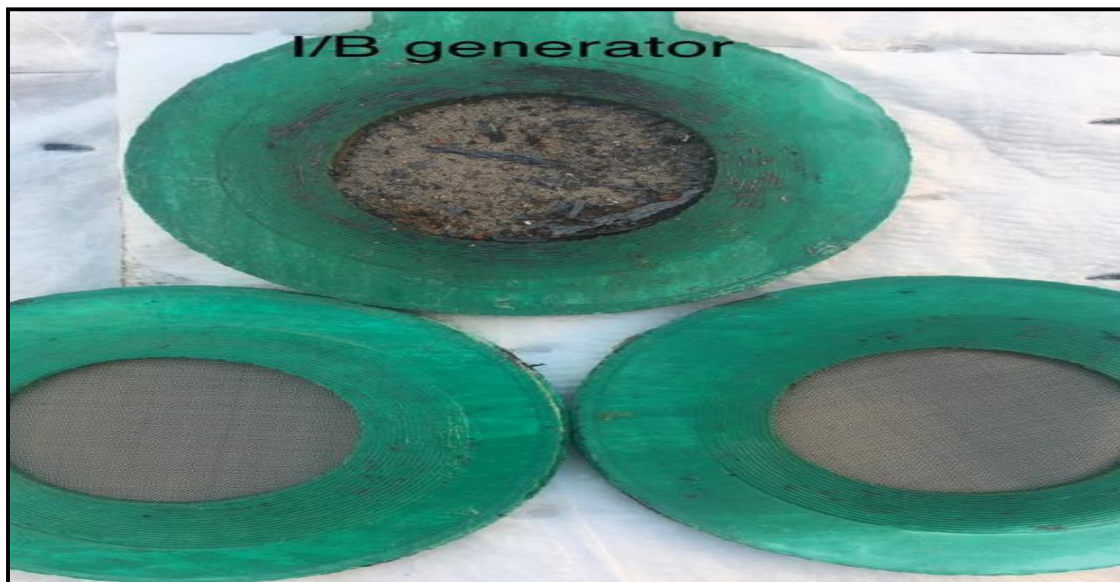
Inspection Screen photos

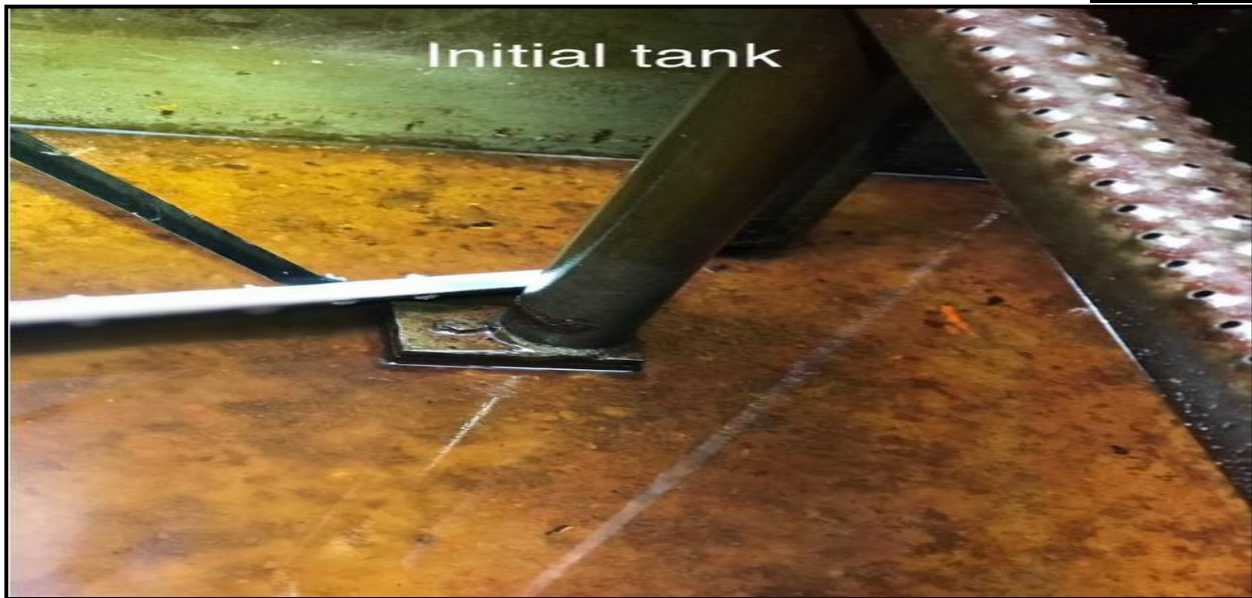
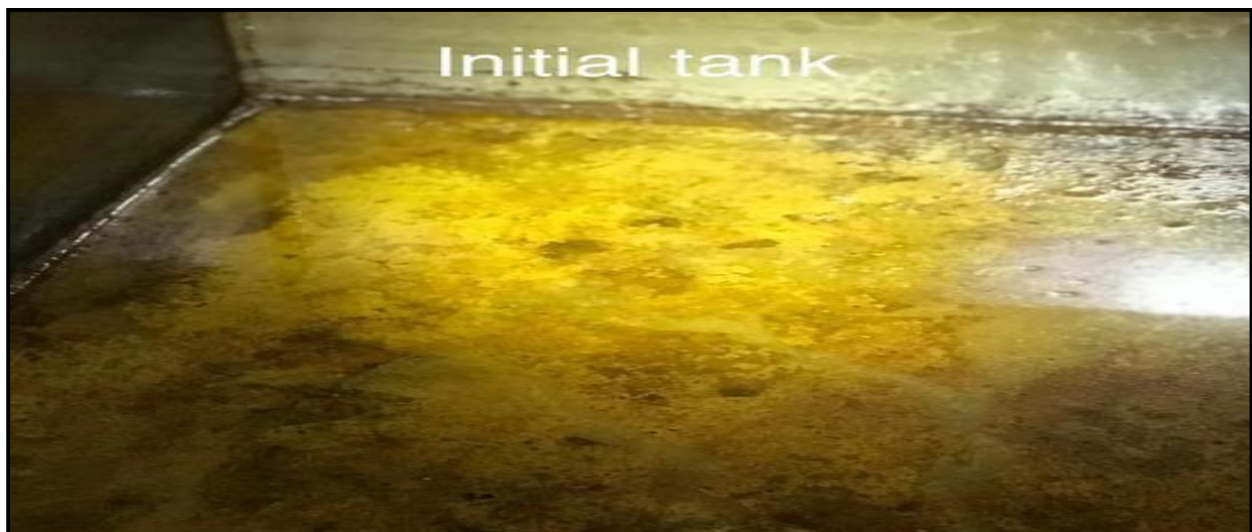
Tank photos
